NRCS Actions: NRCS staff have been in the field since Sunday morning, evaluating damage across the entire area affected by the June 7 - 8 storms. We're working closely with local partners, County staff, and the State Dam Safety Engineers, and taking precautions to ensure inspections are completed safely.

High Risk Structures: The Wisconsin State Conservationist has received approval for EWP funds to provide emergency repairs for the following three dams in Vernon County, to prevent further damage or failure -

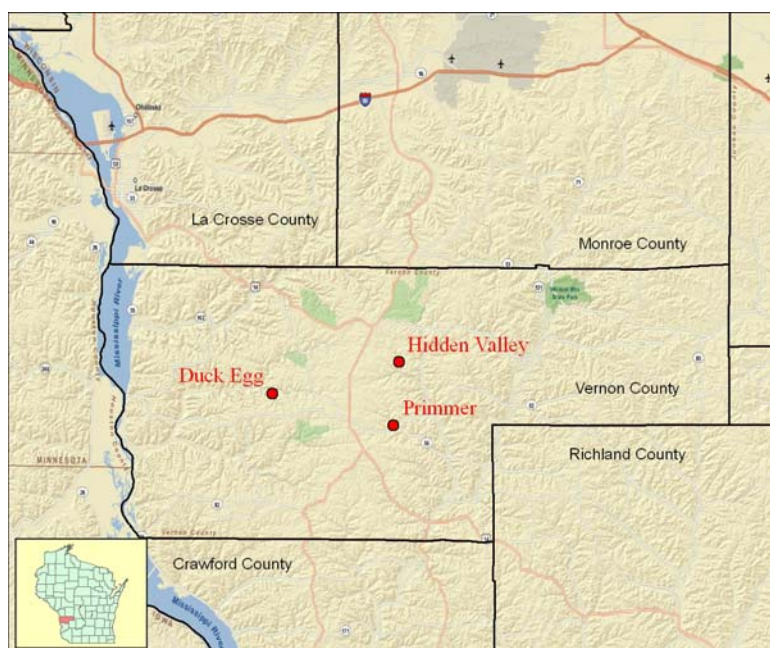
West Fork 17 (Primmer) is in danger of failing. The water level on June 9 was 2 feet over the top riser. Seepage and slumping from the right abutment has moved upstream to the base of the dam. A state highway, 2 homes, and a bridge are at risk downstream from the dam. An emergency controlled partial breach of the dam will begin today (6-11-08).
